**To Redesign the Existing
Freedom Center located at
Freedom Park**

**Request for Proposal:
Due November 5, 2025, 2:00 pm**

Request for Proposals – Professional Design Services Freedom Center Re-Design

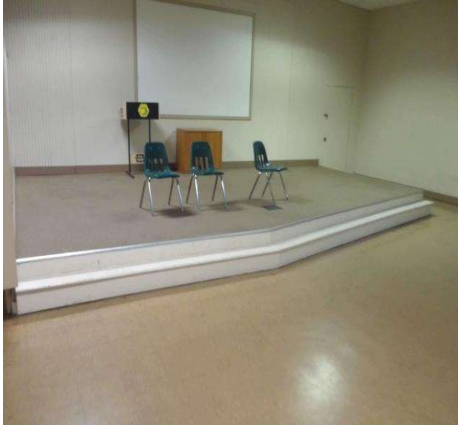
Finding	Recommendation	Projected Date	Actual Date	Est. Cost	Act. Cost	Photo
<p>Record Number 17040</p> <p>Stairs to Multipurpose Room Stage</p> <p>Run 1</p> <p>There is no detectable striping on the stairways.</p> <p>Finding None Found</p> <p>ADA 504, CA 11B-504.4</p>	<p>Affix compliant contrasting striping to the upper approach and each tread that is the correct width and distance from the nosing.</p>	<p>Priority Not Set</p> <p>Resolution Not Set</p> <p>Progress Not Set</p> <p>Assignment Not Set</p>		<p>\$1,000</p>	<p>\$0.00</p>

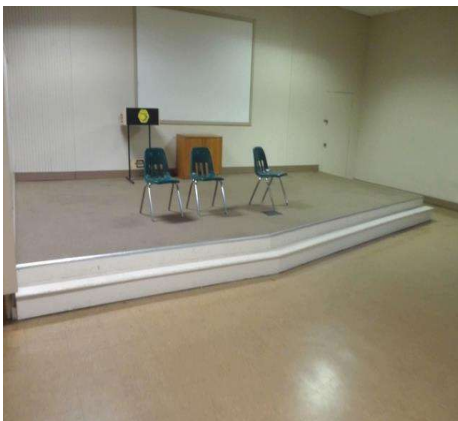
<p>Record Number 17036</p> <p>Stairs to Multipurpose Room Stage</p> <p>Run 1</p> <p>There are no handrails provided on the stairway.</p> <p>Finding None Found</p> <p>ADA 504, 505.2, 504.6, CA 11B-504.6, 505.2</p>	<p>Provide compliant handrails.</p>	<p>Priority Not Set</p> <p>Resolution Not Set</p> <p>Progress Not Set</p> <p>Assignment Not Set</p>		<p>\$1,528</p>	<p>\$0.00</p>

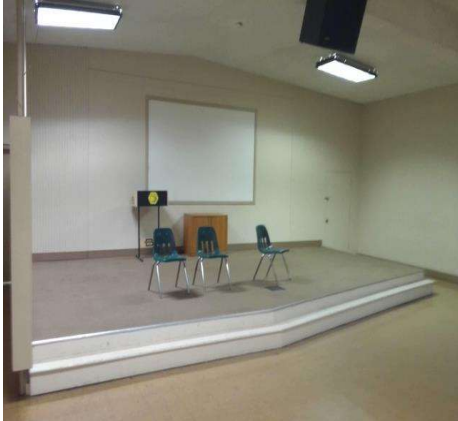
<p>Record Number 17035</p> <p>Stairs to Multipurpose Room Stage</p> <p>Stairway is marked as primary access. There is no other means of vertical access.</p> <p>Finding No Access</p> <p>ADA 210, 504, 206.2, 402.2, CA 11B-206.2, 210, 402.2, 504</p>	<p>Provide a compliant means of vertical access.</p>	<p>Priority Not Set</p> <p>Resolution Not Set</p> <p>Progress Not Set</p> <p>Assignment Not Set</p>		<p>\$4,816</p>	<p>\$0.00</p>

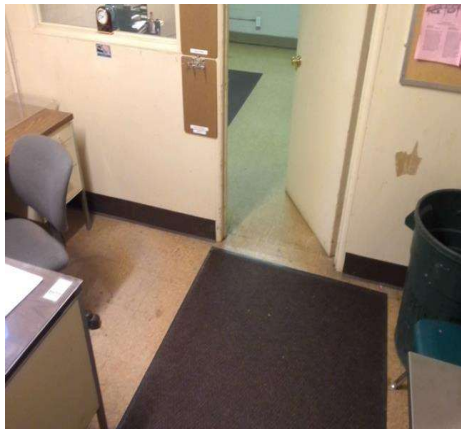
Finding	Recommendation	Projected Date	Actual Date	Est. Cost	Act. Cost	Photo
<p>Record Number 17069</p> <p>Freedom Center Front Office</p> <p>Push Side</p> <p>An unstable floor mat is provided at the door landing.</p> <p>ADA 403.2, 302.1, CA 11B-302.1,403.2</p>	<p>Provide a compliant floor mat for the door.</p>	<p>Priority Not Set</p> <p>Resolution Not Set</p> <p>Progress Not Set</p> <p>Assignment Not Set</p>		<p>\$126</p>	<p>\$0.00</p>

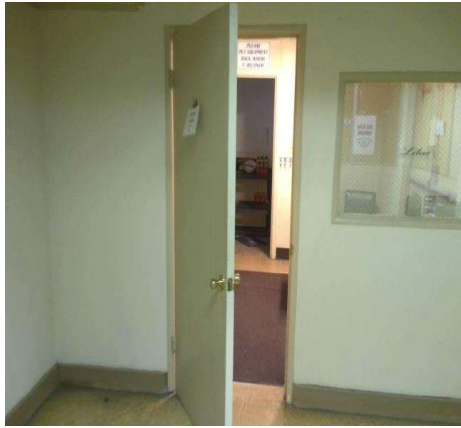
<p>Record Number 17068</p> <p>Freedom Center Front Office</p> <p>Single Knob</p> <p>The door opening hardware is not accessible.</p> <p>Finding Not Accessible</p> <p>ADA 404.2, CA 11B-404.2</p>	<p>Provide accessible hardware on the door.</p>	<p>Priority Not Set</p> <p>Resolution Not Set</p> <p>Progress Not Set</p> <p>Assignment Not Set</p>		<p>\$800</p>	<p>\$0.00</p>	 
<p>Record Number 17067</p> <p>Freedom Center Front Office</p> <p>The clear opening width of the door is less than required.</p> <p>Finding 29.25 inches</p> <p>Code At least 32.00 inches</p> <p>ADA 404, 404.2, CA 11B-404.2</p>	<p>Widen the door opening and install a door that provides at least the minimum clear width with the door open 90 degrees.</p>	<p>Priority Not Set</p> <p>Resolution Not Set</p> <p>Progress Not Set</p> <p>Assignment Not Set</p>		<p>\$1,750</p>	<p>\$0.00</p>

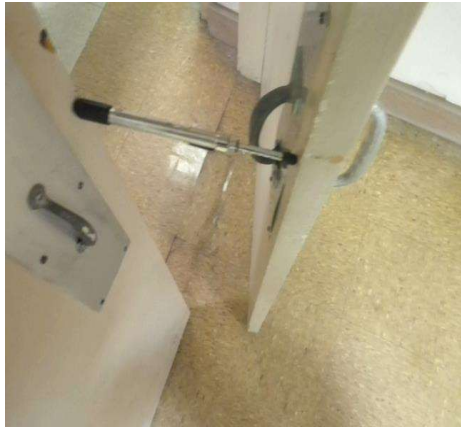
Finding	Recommendation	Projected Date	Actual Date	Est. Cost	Act. Cost	Photo
<p>Record Number 16939</p> <p>Freedom Center Hallway Next to Mens Restroom Push / Pull</p> <p>The door opening force for this door is greater than allowed.</p> <p>Finding 8.00 pounds Code Up to 5.00 pounds ADA 404.2, CA 11B-404.2</p>	<p>Adjust the closer on the door to meet the door opening force requirements.</p>	<p>Priority Not Set</p> <p>Resolution Not Set</p> <p>Progress Not Set</p> <p>Assignment Not Set</p>		<p>\$25</p>	<p>\$0.00</p>

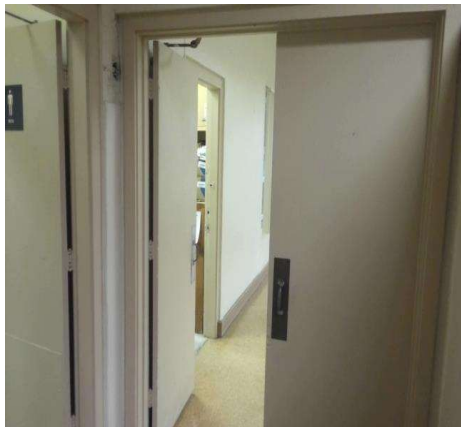
<p>Record Number 16938</p> <p>Freedom Center Hallway Next to Mens Restroom</p> <p>The clear opening width of the door is less than required.</p> <p>Finding 28.00 inches Code At least 32.00 inches ADA 404, 404.2, CA 11B-404.2</p>	<p>Widen the door opening and install a door that provides at least the minimum clear width with the door open 90 degrees.</p>	<p>Priority Not Set</p> <p>Resolution Not Set</p> <p>Progress Not Set</p> <p>Assignment Not Set</p>		<p>\$1,750</p>	<p>\$0.00</p>

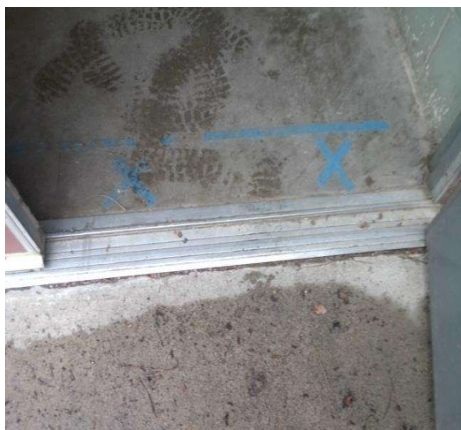
<p>Record Number 17028</p> <p>Freedom Center Kitchen Exterior Entrance</p> <p>The height of the threshold at the entrance door is greater than allowed.</p> <p>Finding 0.75 inches Code Up to 0.50 inches ADA 404, 404.2, CA 11B-404.2</p>	<p>Modify or replace the threshold to provide the recommended height.</p>	<p>Priority Not Set</p> <p>Resolution Not Set</p> <p>Progress Not Set</p> <p>Assignment Not Set</p>		<p>\$436</p>	<p>\$0.00</p>

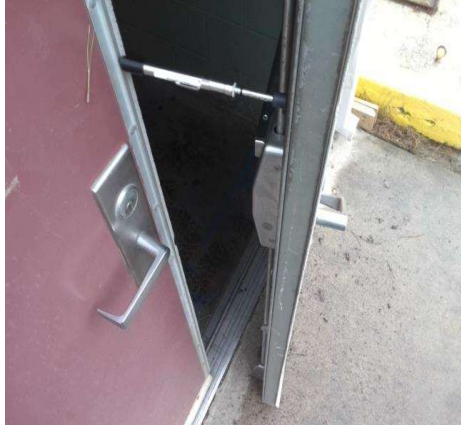
Finding	Recommendation	Projected Date	Actual Date	Est. Cost	Act. Cost	Photo
<p>Record Number 17027</p> <p>Freedom Center Kitchen Exterior Entrance</p> <p>Push Bar / D Handle</p> <p>The bottom of the door or gate does not provide a smooth surface on the push side extending the full width of the door or gate.</p> <p>Finding None Found</p> <p>ADA 404.2, CA 11B-404.2</p>	<p>Install a smooth uninterrupted surface or panel on the push side, extending the full width of the door or gate.</p>	<p>Priority Not Set</p> <p>Resolution Not Set</p> <p>Progress Not Set</p> <p>Assignment Not Set</p>		<p>\$400</p>	<p>\$0.00</p>

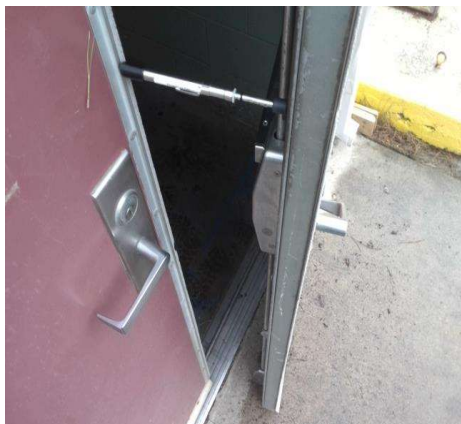
<p>Record Number 17026</p> <p>Freedom Center Kitchen Exterior Entrance</p> <p>Push Bar / D Handle</p> <p>The door opening force for this door is greater than allowed.</p> <p>Finding 10.00 pounds</p> <p>Code Up to 5.00 pounds</p> <p>ADA 404.2, CA 11B-404.2</p>	<p>Adjust the closer on the door to meet the door opening force requirements.</p>	<p>Priority Not Set</p> <p>Resolution Not Set</p> <p>Progress Not Set</p> <p>Assignment Not Set</p>		<p>\$25</p>	<p>\$0.00</p>

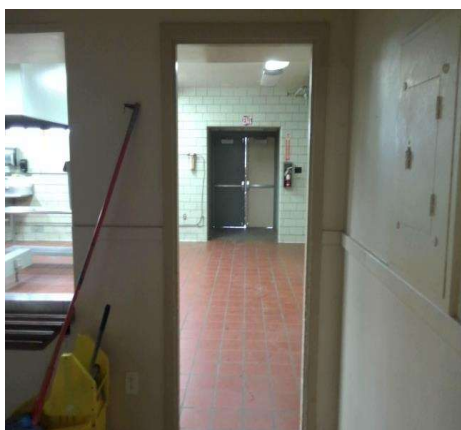
<p>Record Number 17188</p> <p>Freedom Center Kitchen Inner</p> <p>The clear opening width of the doorway is not compliant.</p> <p>Finding 31.00 inches</p> <p>Code At least 32.00 inches</p> <p>ADA 404, 404.2</p>	<p>Widen the door opening and install a door that provides at least the minimum clear width with the door open 90 degrees.</p>	<p>Priority Not Set</p> <p>Resolution Not Set</p> <p>Progress Not Set</p> <p>Assignment Not Set</p>		<p>\$1,800</p>	<p>\$0.00</p>

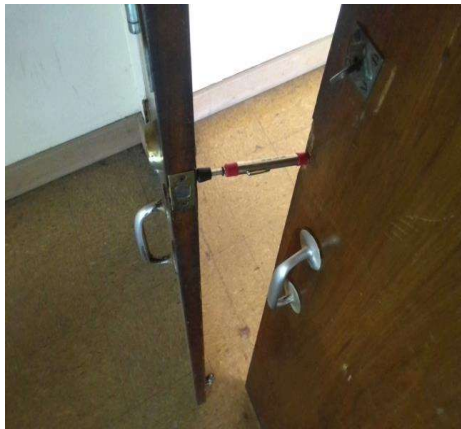
Finding	Recommendation	Projected Date	Actual Date	Est. Cost	Act. Cost	Photo
<p>Record Number 17008</p> <p>Freedom Center Kitchen Outer</p> <p>Push / Pull</p> <p>The door opening force for this door is greater than allowed.</p> <p>Finding 6.00 pounds Code Up to 5.00 pounds ADA 404.2, CA 11B-404.2</p>	<p>Adjust the closer on the door to meet the door opening force requirements.</p>	<p>Priority Not Set</p> <p>Resolution Not Set</p> <p>Progress Not Set</p> <p>Assignment Not Set</p>		<p>\$25</p>	<p>\$0.00</p>

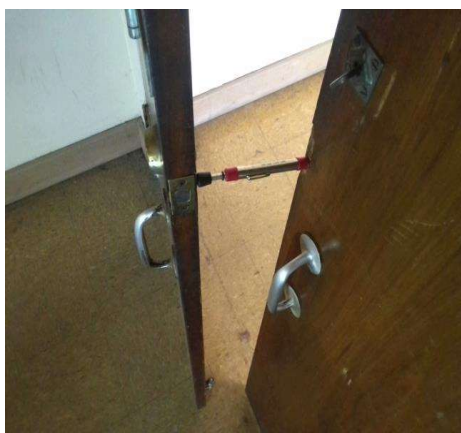
<p>Record Number 17009</p> <p>Freedom Center Kitchen Outer</p> <p>Push / Pull</p> <p>Has a door stop.</p> <p>Finding Found ADA 404, 404.2, CA 11B-404.2</p>	<p>Remove the door stop.</p>	<p>Priority Not Set</p> <p>Resolution Not Set</p> <p>Progress Not Set</p> <p>Assignment Not Set</p>		<p>\$50</p>	<p>\$0.00</p>

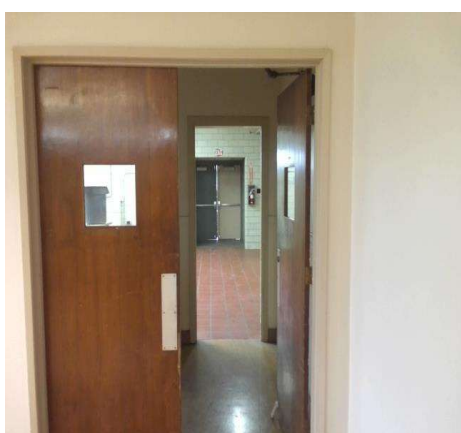
<p>Record Number 17007</p> <p>Freedom Center Kitchen Outer</p> <p>The clear opening width of the door is less than required.</p> <p>Finding 30.12 inches Code At least 32.00 inches ADA 404, 404.2, CA 11B-404.2</p>	<p>Widen the door opening and install a door that provides at least the minimum clear width with the door open 90 degrees.</p>	<p>Priority Not Set</p> <p>Resolution Not Set</p> <p>Progress Not Set</p> <p>Assignment Not Set</p>		<p>\$1,750</p>	<p>\$0.00</p>

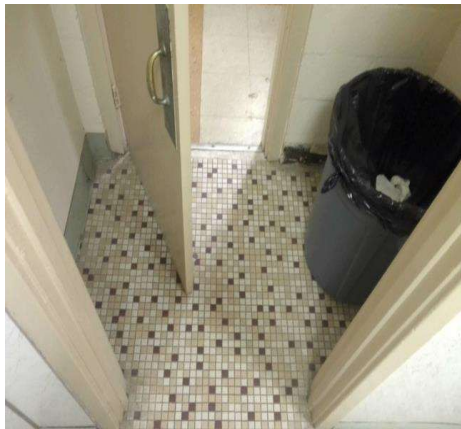
Finding	Recommendation	Projected Date	Actual Date	Est. Cost	Act. Cost	Photo
<p>Record Number 16937</p> <p>Freedom Center Mens Restroom Outer</p> <p>Pull Side</p> <p>There is not enough clear floor space provided at the pull side of the door.</p> <p>Finding 37.50 inches</p> <p>Code At least 60.00 inches</p> <p>ADA 404, 404.2, CA 11B-404.2</p>	<p>Provide the recommended clear floor space on the pull side of the door.</p>	<p>Priority</p> <p>Not Set</p> <p>Resolution</p> <p>Not Set</p> <p>Progress</p> <p>Not Set</p> <p>Assignment</p> <p>Not Set</p>		<p>\$2,921</p>	<p>\$0.00</p>

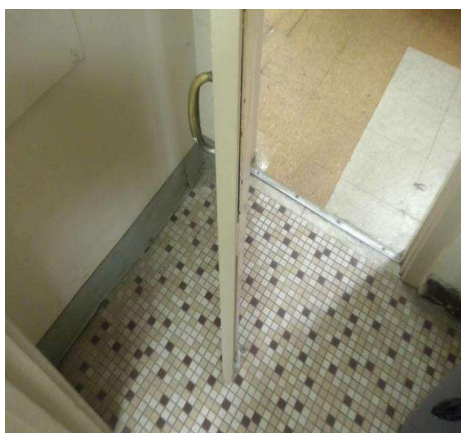
<p>Record Number 16936</p> <p>Freedom Center Mens Restroom Outer</p> <p>Push / Pull</p> <p>Has a door stop.</p> <p>Finding Found</p> <p>ADA 404, 404.2, CA 11B-404.2</p>	<p>Remove the door stop.</p>	<p>Priority</p> <p>Not Set</p> <p>Resolution</p> <p>Not Set</p> <p>Progress</p> <p>Not Set</p> <p>Assignment</p> <p>Not Set</p>		<p>\$50</p>	<p>\$0.00</p>

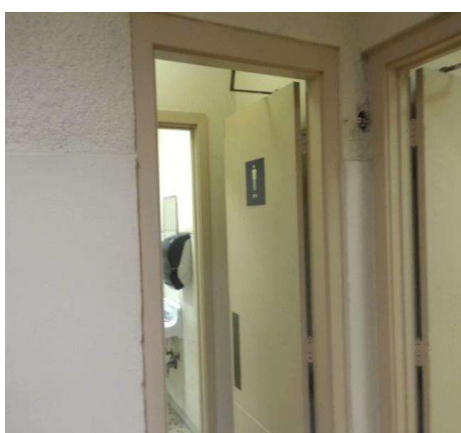
<p>Record Number 16935</p> <p>Freedom Center Mens Restroom Outer</p> <p>The clear opening width of the door is less than required.</p> <p>Finding 27.50 inches</p> <p>Code At least 32.00 inches</p> <p>ADA 404, 404.2, CA 11B-404.2</p>	<p>Widen the door opening and install a door that provides at least the minimum clear width with the door open 90 degrees.</p>	<p>Priority</p> <p>Not Set</p> <p>Resolution</p> <p>Not Set</p> <p>Progress</p> <p>Not Set</p> <p>Assignment</p> <p>Not Set</p>		<p>\$1,750</p>	<p>\$0.00</p>

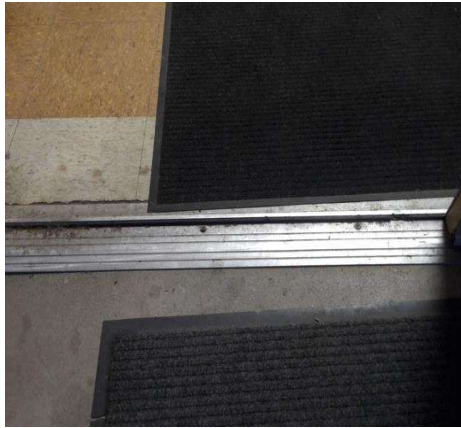
Finding	Recommendation	Projected Date	Actual Date	Est. Cost	Act. Cost	Photo
<p>Record Number 17075</p> <p>Freedom Center Multipurpose Room East Exterior Entrance</p> <p>The height of the threshold at the entrance door is greater than allowed for a vertical rise.</p> <p>Finding 0.50 inches</p> <p>ADA 404, 404.2, CA 11B-404.2</p>	<p>Modify or replace the threshold to provide the recommended height.</p>	<p>Priority Not Set</p> <p>Resolution Not Set</p> <p>Progress Not Set</p> <p>Assignment Not Set</p>		<p>\$257</p>	<p>\$0.00</p>

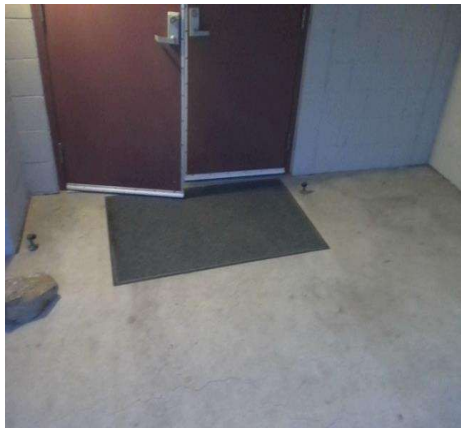
<p>Record Number 17077</p> <p>Freedom Center Multipurpose Room East Exterior Entrance Pull Side</p> <p>An unstable floor mat is provided at the door landing.</p> <p>ADA 403.2, 302.1, CA 11B-302.1,403.2</p>	<p>Provide a compliant floor mat for the door.</p>	<p>Priority Not Set</p> <p>Resolution Not Set</p> <p>Progress Not Set</p> <p>Assignment Not Set</p>		<p>\$126</p>	<p>\$0.00</p>

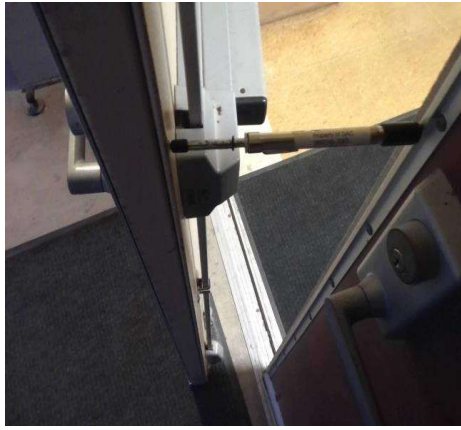
<p>Record Number 17073</p> <p>Freedom Center Multipurpose Room East Exterior Entrance Push Bar / Lever</p> <p>The bottom of the door or gate does not provide a smooth surface on the push side extending the full width of the door or gate.</p> <p>Finding None Found</p> <p>ADA 404.2, CA 11B-404.2</p>	<p>Install a smooth uninterrupted surface or panel on the push side, extending the full width of the door or gate.</p>	<p>Priority Not Set</p> <p>Resolution Not Set</p> <p>Progress Not Set</p> <p>Assignment Not Set</p>		<p>\$400</p>	<p>\$0.00</p>

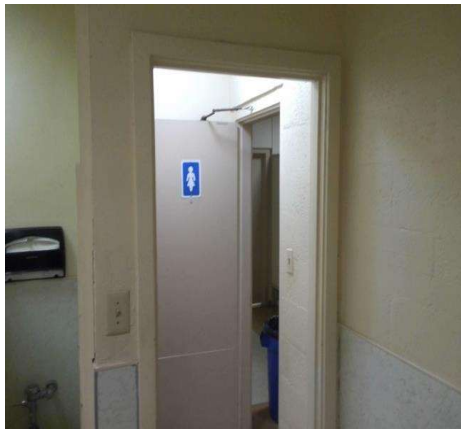
Finding	Recommendation	Projected Date	Actual Date	Est. Cost	Act. Cost	Photo
<p>Record Number 17066</p> <p>Freedom Center Womens Restroom Inner</p> <p>The clear opening width of the doorway is not compliant.</p> <p>Finding 28.87 inches Code At least 32.00 inches ADA 404, 404.2</p>	<p>Widen the door opening and install a door that provides at least the minimum clear width with the door open 90 degrees.</p>	<p>Priority Not Set</p> <p>Resolution Not Set</p> <p>Progress Not Set</p> <p>Assignment Not Set</p>		<p>\$1,800</p>	<p>\$0.00</p>

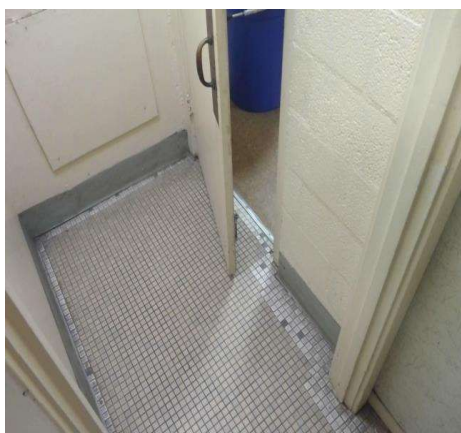
<p>Record Number 17228</p> <p>Freedom Center Womens Restroom Outer</p> <p>Pull Side</p> <p>There is not enough clear floor space provided at the pull side of the door.</p> <p>Finding 39.50 inches Code At least 60.00 inches ADA 404, 404.2, CA 11B-404.2</p>	<p>Provide the recommended clear floor space on the pull side of the door.</p>	<p>Priority Not Set</p> <p>Resolution Not Set</p> <p>Progress Not Set</p> <p>Assignment Not Set</p>		<p>\$2,921</p>	<p>\$0.00</p>

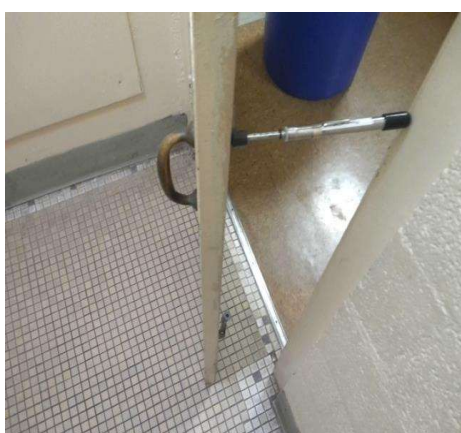
<p>Record Number 17227</p> <p>Freedom Center Womens Restroom Outer</p> <p>Push / Pull</p> <p>Has a door stop.</p> <p>Finding Found</p> <p>ADA 404, 404.2, CA 11B-404.2</p>	<p>Remove the door stop.</p>	<p>Priority Not Set</p> <p>Resolution Not Set</p> <p>Progress Not Set</p> <p>Assignment Not Set</p>		<p>\$50</p>	<p>\$0.00</p>

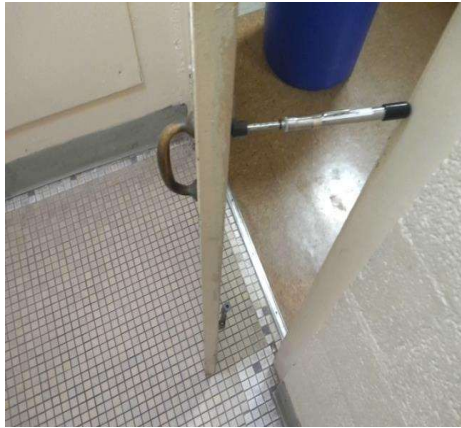
Finding	Recommendation	Projected Date	Actual Date	Est. Cost	Act. Cost	Photo
<p>Record Number 17226</p> <p>Freedom Center Womens Restroom Outer</p> <p>Push / Pull</p> <p>The door opening force for this door is greater than allowed.</p> <p>Finding 9.00 pounds Code Up to 5.00 pounds ADA 404.2, CA 11B-404.2</p>	<p>Adjust the closer on the door to meet the door opening force requirements.</p>	<p>Priority Not Set</p> <p>Resolution Not Set</p> <p>Progress Not Set</p> <p>Assignment Not Set</p>		<p>\$25</p>	<p>\$0.00</p>

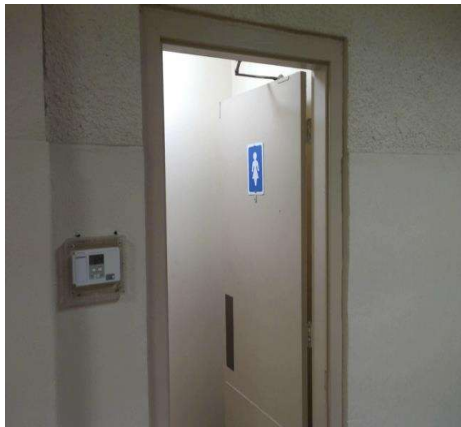
<p>Record Number 17225</p> <p>Freedom Center Womens Restroom Outer</p> <p>The clear opening width of the door is less than required.</p> <p>Finding 27.50 inches Code At least 32.00 inches ADA 404, 404.2, CA 11B-404.2</p>	<p>Widen the door opening and install a door that provides at least the minimum clear width with the door open 90 degrees.</p>	<p>Priority Not Set</p> <p>Resolution Not Set</p> <p>Progress Not Set</p> <p>Assignment Not Set</p>		<p>\$1,750</p>	<p>\$0.00</p>

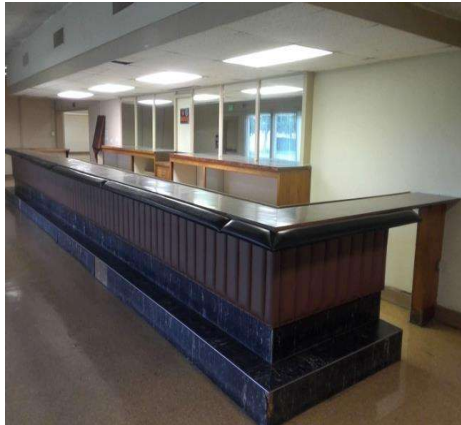
<p>Record Number 17252</p> <p>Freedom Center Bar</p> <p>The height of the counter or desk does not comply with height requirements.</p> <p>Finding 43.37 inches Code 28.00 - 34.00 inches ADA 902, 904, CA 11B-904.4</p>	<p>Provide a portion of counter at the compliant height.</p>	<p>Priority Not Set</p> <p>Resolution Not Set</p> <p>Progress Not Set</p> <p>Assignment Not Set</p>		<p>\$3,500</p>	<p>\$0.00</p>

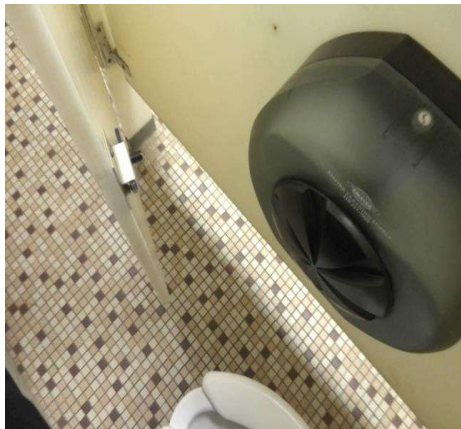
Finding	Recommendation	Projected Date	Actual Date	Est. Cost	Act. Cost	Photo
<p>Record Number 16957 Freedom Center Mens Restroom</p> <p>Door does not close automatically.</p> <p>Finding Missing Hardware</p> <p>ADA 404, 604.8, 604.8, CA 11B-604.8</p>	<p>Provide an automatic door closer, spring hinge, pull bar or accessible handle mounted on the inside of the compartment door to the compartment designated to be accessible.</p>	<p>Priority Not Set</p> <p>Resolution Not Set</p> <p>Progress Not Set</p> <p>Assignment Not Set</p>		<p>\$269</p>	<p>\$0.00</p>

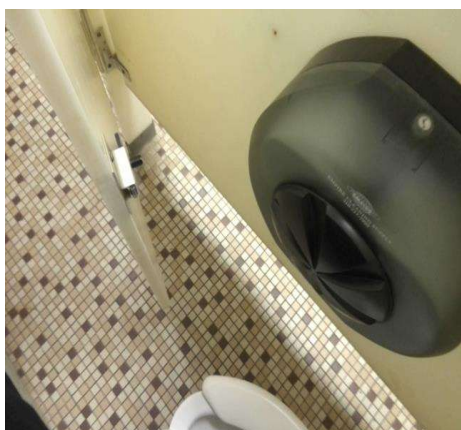
<p>Record Number 16954 Freedom Center Mens Restroom</p> <p>The door to the compartment does not have an accessible handle on both sides.</p> <p>Finding Not on both sides.</p> <p>ADA 404, 213, 604, 604.8, 604.8, CA 11B-404.2,604.8</p>	<p>Provide an accessible handle mounted on the door of the compartment near the latch.</p>	<p>Priority Not Set</p> <p>Resolution Not Set</p> <p>Progress Not Set</p> <p>Assignment Not Set</p>		<p>\$250</p>	<p>\$0.00</p>

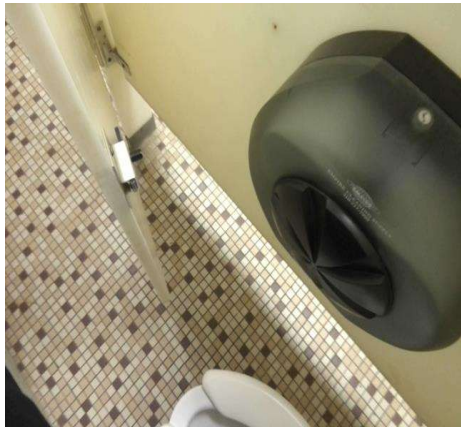
<p>Record Number 16958 Freedom Center Mens Restroom</p> <p>The door to the compartment designated to be accessible in the restroom does not have appropriate accessible hardware.</p> <p>Finding Not Accessible</p> <p>ADA 404, 404.2, 309.4, 604.8, CA 11B-404.2,604.8</p>	<p>Install accessible hardware on the compartment door that does not require tight grasping, pinching, or twisting of the wrist.</p>	<p>Priority Not Set</p> <p>Resolution Not Set</p> <p>Progress Not Set</p> <p>Assignment Not Set</p>		<p>\$289</p>	<p>\$0.00</p>

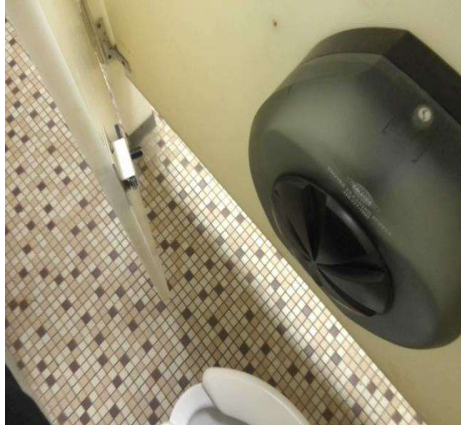
Finding	Recommendation	Projected Date	Actual Date	Est. Cost	Act. Cost	Photo
<p>Record Number 16956 Freedom Center Mens Restroom</p> <p>The compartment door is located in front of the water closet.</p> <p>Finding Not Located</p> <p>ADA 604.8, CA 11B-604.8</p>	<p>Reconfigure the toilet compartment to provide a compliant door that is located adjacent to the water closet.</p>	<p>Priority Not Set</p> <p>Resolution Not Set</p> <p>Progress Not Set</p> <p>Assignment Not Set</p>		<p>\$4,000</p>	<p>\$0.00</p>

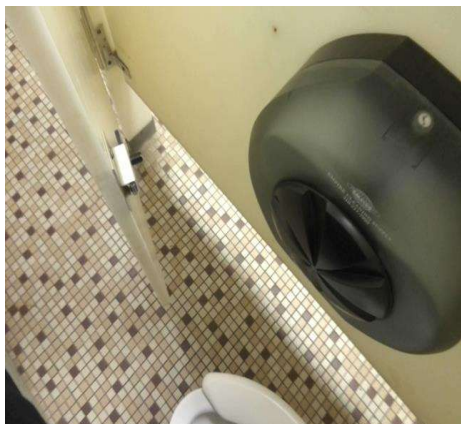
<p>Record Number 16960 Freedom Center Mens Restroom</p> <p>There is less than the required latch side clearance on the pull side of the door.</p> <p>Finding 4.50 inches Code At least 18.00 inches</p> <p>ADA 404, 604.8, 604.8, 404.2, CA 11B-604.8,404</p>	<p>Provide required latch side clearance on the pull side of the door.</p>	<p>Priority Not Set</p> <p>Resolution Not Set</p> <p>Progress Not Set</p> <p>Assignment Not Set</p>		<p>\$2,200</p>	<p>\$0.00</p>

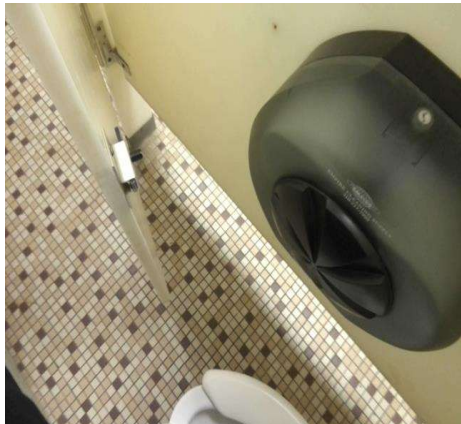
<p>Record Number 16959 Freedom Center Mens Restroom</p> <p>The inside handle is not located near the latch.</p> <p>Finding None Found</p> <p>ADA 404, 213, 604, 604.8, CA 11B-404.2,604.8</p>	<p>Adjust the inside handle so that it is located near the latch.</p>	<p>Priority Not Set</p> <p>Resolution Not Set</p> <p>Progress Not Set</p> <p>Assignment Not Set</p>		<p>\$129</p>	<p>\$0.00</p>

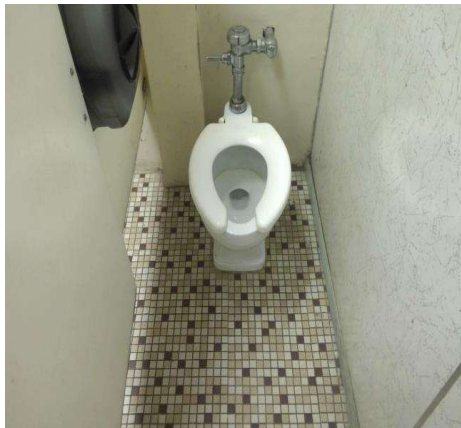
Finding	Recommendation	Projected Date	Actual Date	Est. Cost	Act. Cost	Photo
<p>Record Number 16953 Freedom Center Mens Restroom</p> <p>There is less than the required minimum space in front of the toilet.</p> <p>Finding 30.25 inches Code At least 48.00 inches ADA 603, CA 11B-604.8</p>	<p>Create the required minimum clear space in front of the toilet.</p>	<p>Priority Not Set</p> <p>Resolution Not Set</p> <p>Progress Not Set</p> <p>Assignment Not Set</p>		<p>\$3,500</p>	<p>\$0.00</p>	 
<p>Record Number 16948 Freedom Center Mens Restroom</p> <p>The distance from the center of the toilet to the nearest side wall does not meet the required distance.</p> <p>Finding 14.50 inches on center Code 17.00 - 18.00 inches ADA 603, 604.2, CA 11B-604.2</p>	<p>Relocate the toilet so the distance from the center line of the toilet to the nearest side wall meets the required distance.</p>	<p>Priority Not Set</p> <p>Resolution Not Set</p> <p>Progress Not Set</p> <p>Assignment Not Set</p>		<p>\$2,500</p>	<p>\$0.00</p>

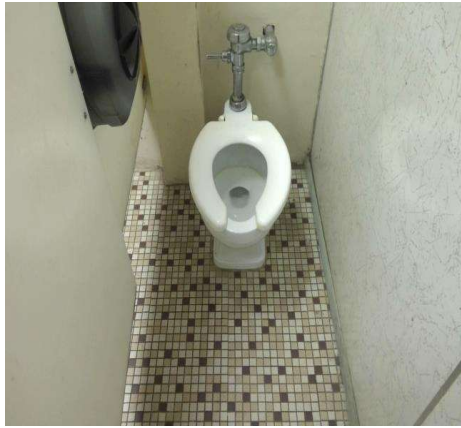
<p>Record Number 16951 Freedom Center Mens Restroom</p> <p>The flush control on the toilet is not on the wide (approach) side of the toilet.</p> <p>Finding Wrong Side of Toilet ADA 603, 604.6, CA 11B-604.6</p>	<p>Relocate the flush control so it is on the wide (approach) side of the toilet area. Flush controls shall be hand-operated or automatic mechanisms.</p>	<p>Priority Not Set</p> <p>Resolution Not Set</p> <p>Progress Not Set</p> <p>Assignment Not Set</p>		<p>\$127</p>	<p>\$0.00</p>

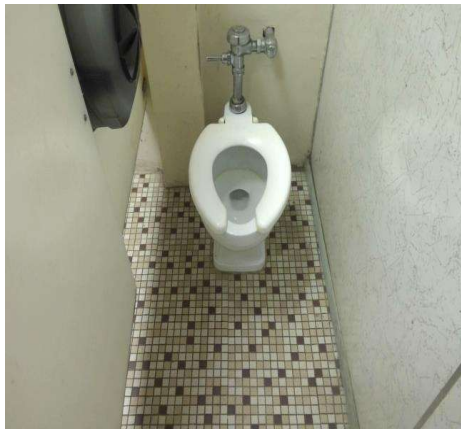
Finding	Recommendation	Projected Date	Actual Date	Est. Cost	Act. Cost	Photo
<p>Record Number 16952 Freedom Center Mens Restroom</p> <p>The toilet does not provide the required distance from the center line to a fixture or wall on the wide side.</p> <p>Finding 16.00 inches Code At least 42.00 inches ADA 603, 604, CA 11B-604</p>	<p>Provide a compliant amount of clearance from the center line of the toilet to the nearest fixture or wall on the wide side.</p>	<p>Priority Not Set</p> <p>Resolution Not Set</p> <p>Progress Not Set</p> <p>Assignment Not Set</p>		\$2,500	\$0.00

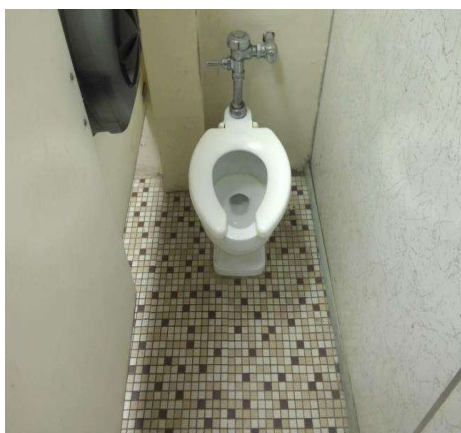
<p>Record Number 16949 Freedom Center Mens Restroom</p> <p>The height of the toilet seat is not at the required height.</p> <p>Finding 16.50 inches Code 17.00 - 19.00 inches ADA 603, 604.4, CA 11B-604.4</p>	<p>Adjust or modify the toilet so the seat height is at the required accessible height.</p>	<p>Priority Not Set</p> <p>Resolution Not Set</p> <p>Progress Not Set</p> <p>Assignment Not Set</p>		\$1,707	\$0.00

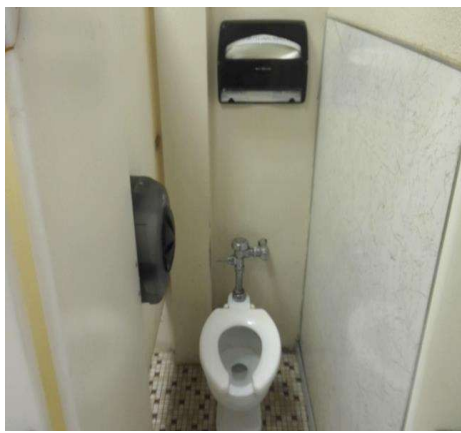
<p>Record Number 16941 Freedom Center Mens Restroom</p> <p>The location of the seat cover dispenser does not provide sufficient clear floor space.</p> <p>Finding Not Accessible</p> <p>ADA 304, 309.2, 305.1, CA 11B-603.5,309.2,305.1</p>	<p>Relocate the seat cover dispenser to a compliant height, that provides sufficient clear floor space, and does not interfere with use of the grab bars.</p>	<p>Priority Not Set</p> <p>Resolution Not Set</p> <p>Progress Not Set</p> <p>Assignment Not Set</p>		\$277	\$0.00

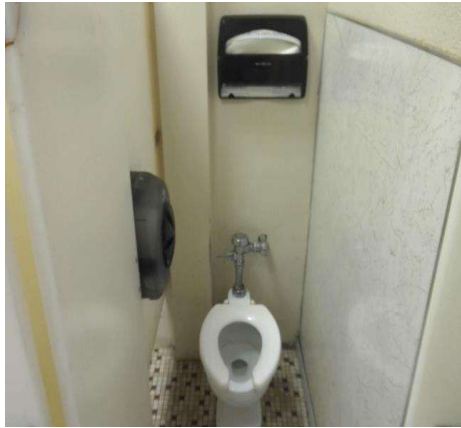
Finding	Recommendation	Projected Date	Actual Date	Est. Cost	Act. Cost	Photo
<p>Record Number 16947 Freedom Center Mens Restroom</p> <p>There are no grab bars.</p> <p>Finding None Found</p> <p>ADA 603, 609, 604.5, CA 11B-604.5</p>	<p>Install the required grab bars in the toilet compartment.</p>	<p>Priority Not Set</p> <p>Resolution Not Set</p> <p>Progress Not Set</p> <p>Assignment Not Set</p>		<p>\$267</p>	<p>\$0.00</p>

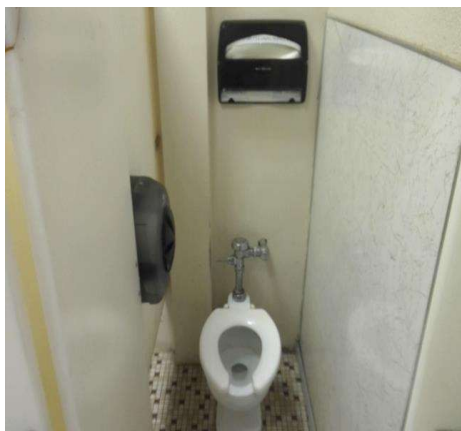
<p>Record Number 16942 Freedom Center Mens Restroom</p> <p>There is no toilet paper dispenser provided on the narrow side wall.</p> <p>Finding None Found</p> <p>ADA 603, 604.7, CA 11B-604.7</p>	<p>Install a compliant toilet paper dispenser.</p>	<p>Priority Not Set</p> <p>Resolution Not Set</p> <p>Progress Not Set</p> <p>Assignment Not Set</p>		<p>\$277</p>	<p>\$0.00</p>

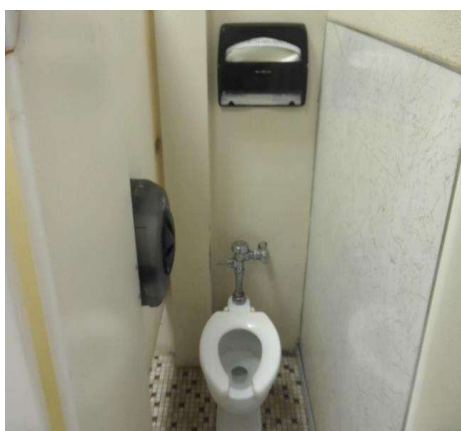
<p>Record Number 16943 Freedom Center Mens Restroom</p> <p>The approach is to the latch side of the compartment door, clearance between the door side of the compartment and any obstruction does not meet the minimum required clearance.</p> <p>Finding 40.00 inches Code At least 42.00 inches</p> <p>ADA 603, 604.8, 404.2, CA 11B-604.8,404.2</p>	<p>Provide clearance between the door side of the compartment and any obstruction that meets the minimum required clearance.</p>	<p>Priority Not Set</p> <p>Resolution Not Set</p> <p>Progress Not Set</p> <p>Assignment Not Set</p>		<p>\$4,000</p>	<p>\$0.00</p>

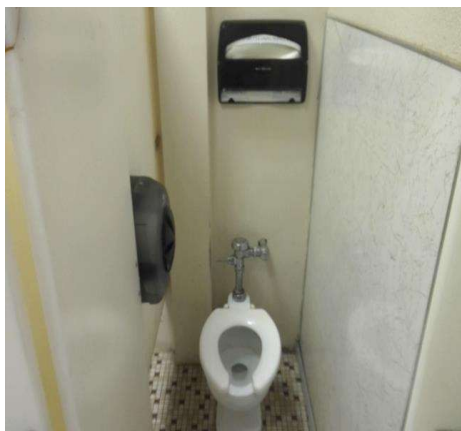
<p>Record Number 16945 Freedom Center Mens Restroom</p> <p>There is insufficient clear floor space in the compartment.</p> <p>Finding 56.25 inches Code At least 59.00 inches ADA 603, 213, 604, 604.8, CA 11B-604.8</p>	<p>Modify or replace the compartment to provide adequate clear floor space.</p>	<p>Priority Not Set</p> <p>Resolution Not Set</p> <p>Progress Not Set</p> <p>Assignment Not Set</p>		<p>\$4,000</p>	<p>\$0.00</p>

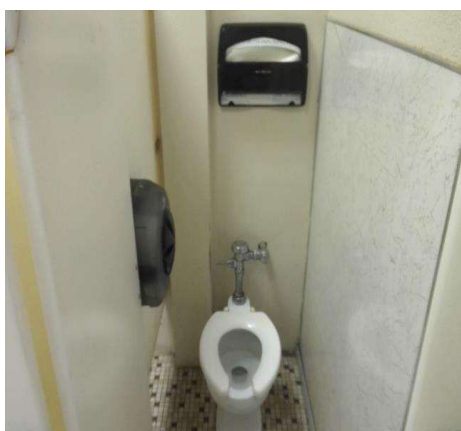
<p>Record Number 16946 Freedom Center Mens Restroom</p> <p>The height of the operable parts of the seat cover dispenser is greater than the allowed maximum height.</p> <p>Finding 56.00 inches Code Up to 40.00 inches ADA 309, 205, 308, 606, 308.2, CA 11B-603.5</p>	<p>Relocate the seat cover dispenser to a compliant height, that provides sufficient clear floor space, and does not interfere with use of the grab bars.</p>	<p>Priority Not Set</p> <p>Resolution Not Set</p> <p>Progress Not Set</p> <p>Assignment Not Set</p>		<p>\$277</p>	<p>\$0.00</p>

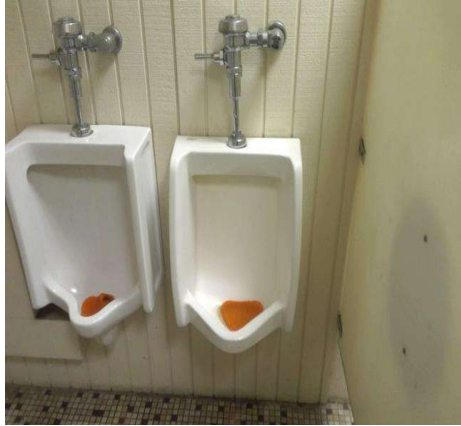
Finding	Recommendation	Projected Date	Actual Date	Est. Cost	Act. Cost	Photo
<p>Record Number 17139 Freedom Center Mens Restroom Outer</p> <p>The height of the urinal rim in the restroom is not compliant.</p> <p>Finding 26.00 inches Code Up to 17.00 inches ADA 605, 605.2, CA 11B-605.2</p>	<p>Lower the urinal designated to be accessible in the restroom so that the rim height is compliant.</p>	<p>Priority Not Set</p> <p>Resolution Not Set</p> <p>Progress Not Set</p> <p>Assignment Not Set</p>		\$1,397	\$0.00

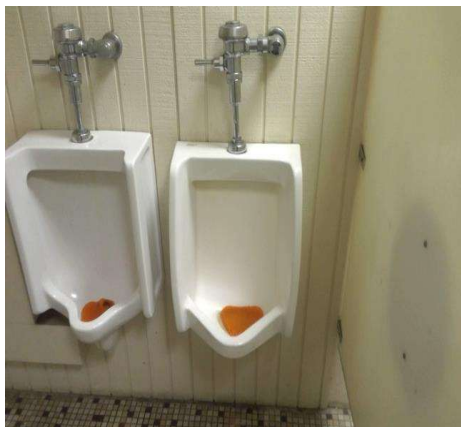
<p>Record Number 17140 Freedom Center Mens Restroom Outer</p> <p>The height of the urinal flush control in the restroom is greater than the required maximum height.</p> <p>Finding 53.00 inches Code Up to 44.00 inches ADA 605, 309.3, 605.4, 308.2, CA 11B-605.4</p>	<p>Lower the flush control valve on the urinal to a height not greater than the required maximum height.</p>	<p>Priority Not Set</p> <p>Resolution Not Set</p> <p>Progress Not Set</p> <p>Assignment Not Set</p>		\$227	\$0.00

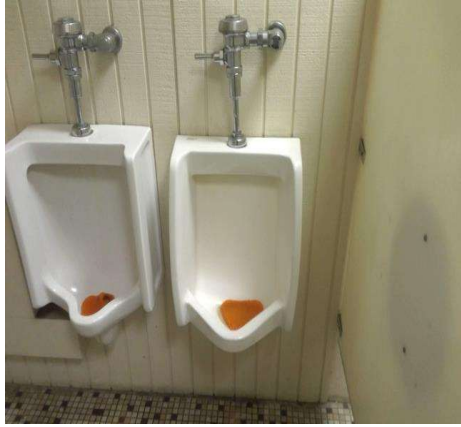
<p>Record Number 17141 Freedom Center Mens Restroom Outer</p> <p>The urinal does not meet the requirement for the minimum projection from the back wall to the front of the urinal rim.</p> <p>Finding 13.00 inches Code At least 13.50 inches ADA 605, 605.2, CA 11B-605.2</p>	<p>Install a urinal that meets the minimum projection requirements.</p>	<p>Priority Not Set</p> <p>Resolution Not Set</p> <p>Progress Not Set</p> <p>Assignment Not Set</p>		\$951	\$0.00

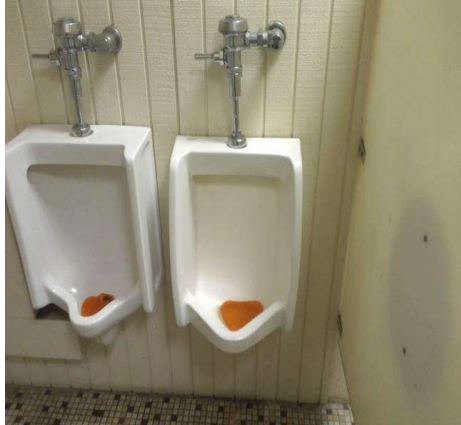
Finding	Recommendation	Projected Date	Actual Date	Est. Cost	Act. Cost	Photo
<p>Record Number 17142 Freedom Center Mens Restroom Outer</p> <p>There is less than the required clear floor space provided in front of the urinal in the restroom to allow an accessible forward approach.</p> <p>Finding 29.75 inches Code At least 30.00 inches ADA 605, 605.3, 305.3, CA 11B-605.3,305.3</p>	<p>Provide the required minimum clear floor space in front of the urinal designated to be accessible in the restroom, for a forward approach.</p>	<p>Priority Not Set</p> <p>Resolution Not Set</p> <p>Progress Not Set</p> <p>Assignment Not Set</p>		\$1,707	\$0.00

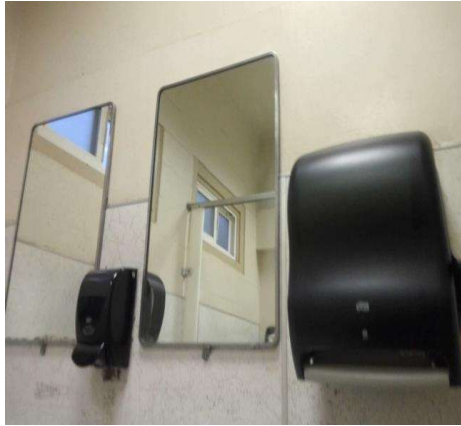
<p>Record Number 17138 Freedom Center Mens Restroom Outer</p> <p>The bottom edge of the reflective surface of the mirror is not at the correct height.</p> <p>Finding 46.50 inches Code Up to 40.00 inches ADA 603, 213, 603.3, CA 11B-603.3</p>	<p>Lower the mirror so the bottom edge of the reflective surface is no higher than recommended above the finished floor.</p>	<p>Priority Not Set</p> <p>Resolution Not Set</p> <p>Progress Not Set</p> <p>Assignment Not Set</p>		\$300	\$0.00

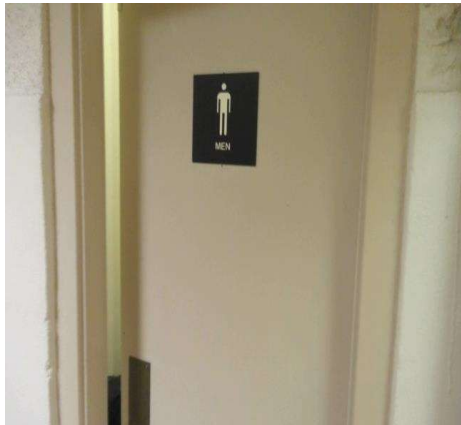
<p>Record Number 17143 Freedom Center Mens Restroom Outer</p> <p>Door Sign - Male</p> <p>There is no gender use signage on the entrance door.</p> <p>Finding None Found CA 11B- 216.8,703.7</p>	<p>Post gender use signage on the center of the door at the required height.</p>	<p>Priority Not Set</p> <p>Resolution Not Set</p> <p>Progress Not Set</p> <p>Assignment Not Set</p>		\$158	\$0.00

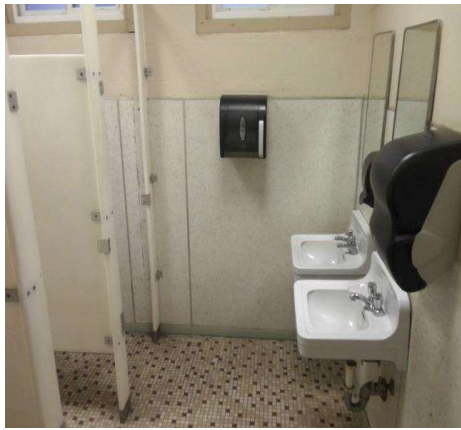
Finding	Recommendation	Projected Date	Actual Date	Est. Cost	Act. Cost	Photo
<p>Record Number 17144</p> <p>Freedom Center Mens Restroom Outer</p> <p>Wall Sign</p> <p>There is no compliant signage indicating accessibility on the latch side of the entry door of the restroom.</p> <p>Finding None Found</p> <p>ADA 703, 216, 216.8, CA 11B-216.8</p>	<p>Provide compliant signage on latch side of door.</p>	<p>Priority Not Set</p> <p>Resolution Not Set</p> <p>Progress Not Set</p> <p>Assignment Not Set</p>		<p>\$158</p>	<p>\$0.00</p>	 
<p>Record Number 17128</p> <p>Freedom Center Mens Restroom Outer</p> <p>There is not sufficient clear floor space in the restroom to accommodate an individual in a wheelchair.</p> <p>Finding 42.50 inches</p> <p>Code At least 60.00 inches</p> <p>ADA 603, 304, 304.3, 603.2, 304.3, 603.2, CA 11B-304.3</p>	<p>Modify the restroom to provide sufficient clear floor space for a turning radius in the restroom to accommodate an individual in a wheelchair.</p>	<p>Priority Not Set</p> <p>Resolution Not Set</p> <p>Progress Not Set</p> <p>Assignment Not Set</p>		<p>\$14,000</p>	<p>\$0.00</p>

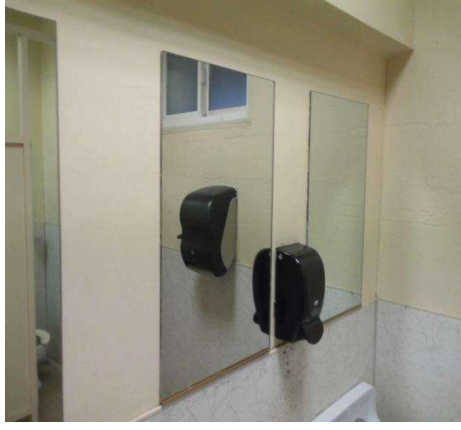
<p>Record Number 17115</p> <p>Freedom Center Womens Restroom</p> <p>The bottom edge of the reflective surface of the mirror is not at the correct height.</p> <p>Finding 48.50 inches</p> <p>Code Up to 40.00 inches</p> <p>ADA 603, 213, 603.3, CA 11B-603.3</p>	<p>Lower the mirror so the bottom edge of the reflective surface is no higher than recommended above the finished floor.</p>	<p>Priority Not Set</p> <p>Resolution Not Set</p> <p>Progress Not Set</p> <p>Assignment Not Set</p>		<p>\$300</p>	<p>\$0.00</p>

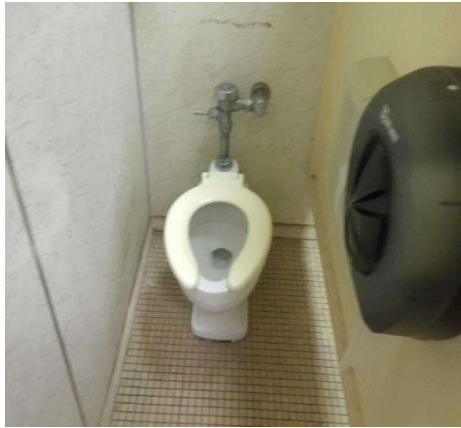
Finding	Recommendation	Projected Date	Actual Date	Est. Cost	Act. Cost	Photo
<p>Record Number 17208 Freedom Center Womens Restroom</p> <p>The flush control on the toilet is not on the wide (approach) side of the toilet.</p> <p>Finding Wrong Side of Toilet</p> <p>ADA 603, 604.6, CA 11B-604.6</p>	<p>Relocate the flush control so it is on the wide (approach) side of the toilet area. Flush controls shall be hand-operated or automatic mechanisms.</p>	<p>Priority Not Set</p> <p>Resolution Not Set</p> <p>Progress Not Set</p> <p>Assignment Not Set</p>		<p>\$127</p>	<p>\$0.00</p>

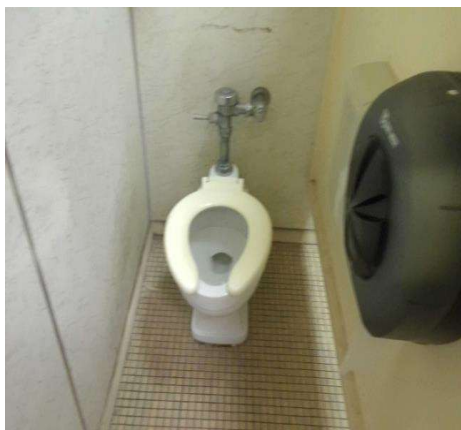
<p>Record Number 17206 Freedom Center Womens Restroom</p> <p>The height of the toilet seat is not at the required height.</p> <p>Finding 16.50 inches Code 17.00 - 19.00 inches</p> <p>ADA 603, 604.4, CA 11B-604.4</p>	<p>Adjust or modify the toilet so the seat height is at the required accessible height.</p>	<p>Priority Not Set</p> <p>Resolution Not Set</p> <p>Progress Not Set</p> <p>Assignment Not Set</p>		<p>\$1,707</p>	<p>\$0.00</p>

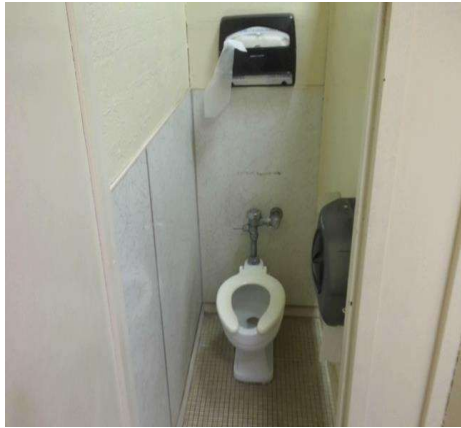
Finding	Recommendation	Projected Date	Actual Date	Est. Cost	Act. Cost	Photo
<p>Record Number 17203 Freedom Center Womens Restroom</p> <p>The height of the operable parts of the seat cover dispenser is greater than the allowed maximum height.</p> <p>Finding 56.00 inches Code Up to 40.00 inches ADA 309, 205, 308, 606, 308.2, CA 11B-60 3.5</p>	<p>Relocate the seat cover dispenser to a compliant height, that provides sufficient clear floor space, and does not interfere with use of the grab bars.</p>	<p>Priority Not Set</p> <p>Resolution Not Set</p> <p>Progress Not Set</p> <p>Assignment Not Set</p>		\$277	\$0.00

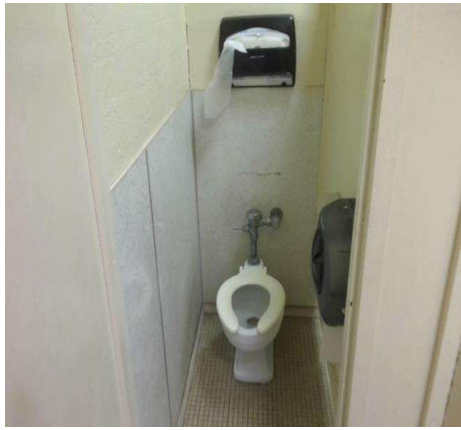
<p>Record Number 17201 Freedom Center Womens Restroom</p> <p>There is insufficient clear floor space in the compartment.</p> <p>Finding 29.75 inches Code At least 60.00 inches ADA 603, 213, 604, 604.8, CA 11B-604.8</p>	<p>Modify or replace the compartment to provide adequate clear floor space.</p>	<p>Priority Not Set</p> <p>Resolution Not Set</p> <p>Progress Not Set</p> <p>Assignment Not Set</p>		\$4,000	\$0.00

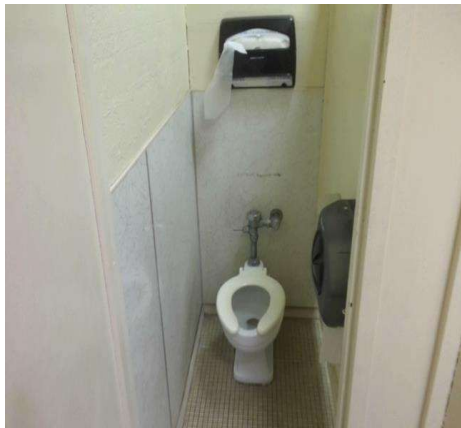
<p>Record Number 17202 Freedom Center Womens Restroom</p> <p>There is insufficient clear floor space in the compartment.</p> <p>Finding 55.50 inches Code At least 59.00 inches ADA 603, 213, 604, 604.8, CA 11B-604.8</p>	<p>Modify or replace the compartment to provide adequate clear floor space.</p>	<p>Priority Not Set</p> <p>Resolution Not Set</p> <p>Progress Not Set</p> <p>Assignment Not Set</p>		\$4,000	\$0.00

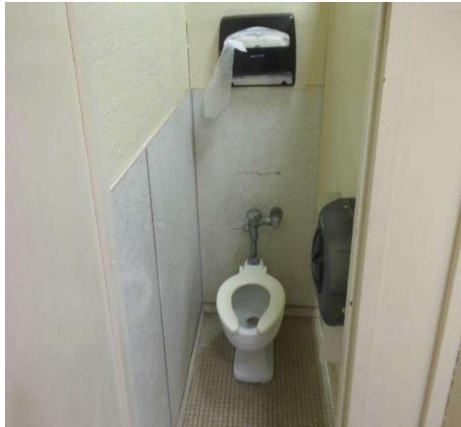
Finding	Recommendation	Projected Date	Actual Date	Est. Cost	Act. Cost	Photo
<p>Record Number 17199 Freedom Center Womens Restroom</p> <p>The location of the seat cover dispenser does not provide sufficient clear floor space.</p> <p>Finding Not Accessible</p> <p>ADA 304, 309.2, 305.1, CA 11B-603.5,309.2,305.1</p>	<p>Relocate the seat cover dispenser to a compliant height, that provides sufficient clear floor space, and does not interfere with use of the grab bars.</p>	<p>Priority Not Set</p> <p>Resolution Not Set</p> <p>Progress Not Set</p> <p>Assignment Not Set</p>		<p>\$277</p>	<p>\$0.00</p>

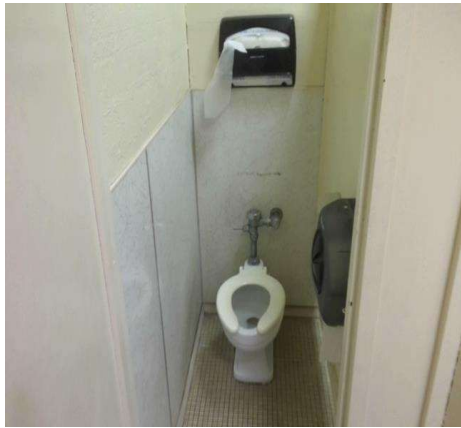
<p>Record Number 17200 Freedom Center Womens Restroom</p> <p>There is no toilet paper dispenser provided on the narrow side wall.</p> <p>Finding None Found</p> <p>ADA 603, 604.7, CA 11B-604.7</p>	<p>Install a compliant toilet paper dispenser.</p>	<p>Priority Not Set</p> <p>Resolution Not Set</p> <p>Progress Not Set</p> <p>Assignment Not Set</p>		<p>\$277</p>	<p>\$0.00</p>

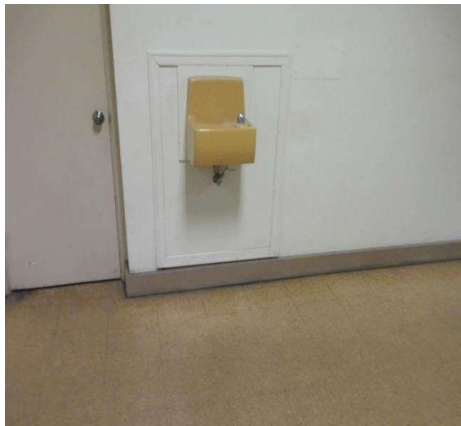
<p>Record Number 17265 Multipurpose Room</p> <p>Drinking fountain does not provide a required fountain depth.</p> <p>Finding 12.50 inches Code At least 18.00 inches</p> <p>ADA 305, 306, 211, 602, CA 11B-602.8</p>	<p>Install a drinking fountain the meets the required minimum depth.</p>	<p>Priority Not Set</p> <p>Resolution Not Set</p> <p>Progress Not Set</p> <p>Assignment Not Set</p>		<p>\$2,500</p>	<p>\$0.00</p>

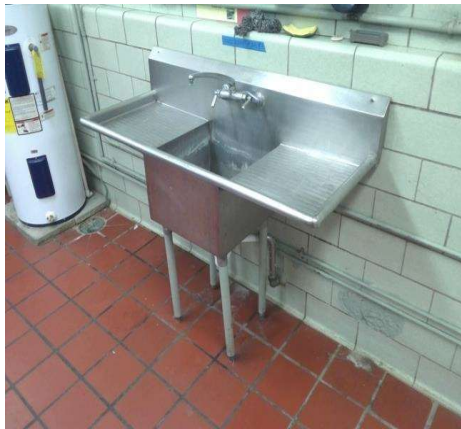
Finding	Recommendation	Projected Date	Actual Date	Est. Cost	Act. Cost	Photo
<p>Record Number 16978 Freedom Center Kitchen</p> <p>The pipes are not wrapped for the sink.</p> <p>Finding Not Wrapped</p> <p>ADA 606.5, CA 11B-606.5</p>	<p>Insulate or Otherwise configure pipes under the sink to protect against contact. Make certain there are no sharp or abrasive surfaces under the sink.</p>	<p>Priority Not Set</p> <p>Resolution Not Set</p> <p>Progress Not Set</p> <p>Assignment Not Set</p>		<p>\$149</p>	<p>\$0.00</p>
