**PLEASANT VALLEY RECREATION & PARK DISTRICT  
CITY HALL COUNCIL CHAMBERS  
601 CARMEN DR., CAMARILLO, CALIFORNIA**

**A. Senior and Community Recreation Facility Final Design Plan**

SENIOR AND COMMUNITY RECREATION FACILITY

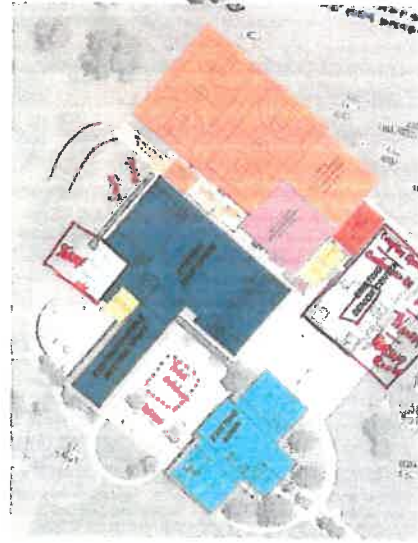
## WS#1 Review: Theme - East Infill

- East and south side expansion
- Self-describe “Events Center”
- Leaves intact existing auditorium, classrooms, admin. building
- New senior wing
- Distinct similarities across all three group plans

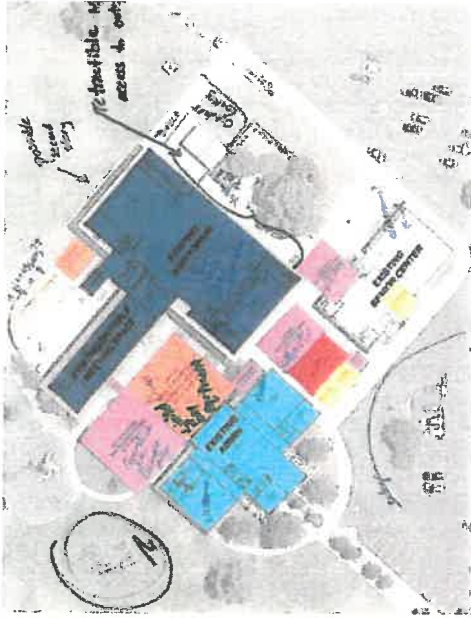
Group 7

- "Preserve Landscape"; works within existing footprint

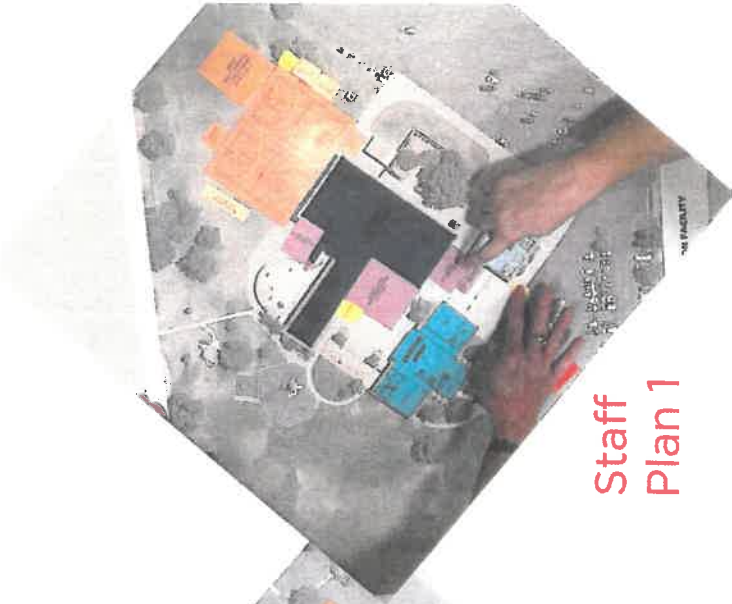
Staff  
Plan 1

- Expand facilities to the north

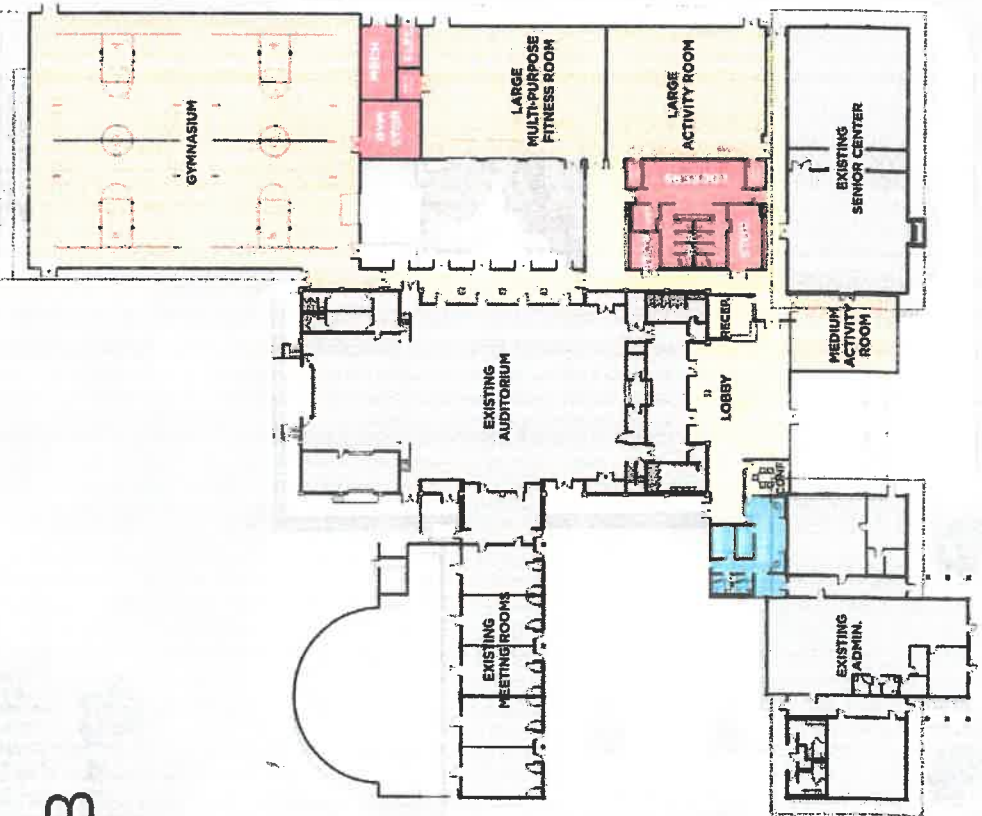
## OPTION-B

like that the back grounds are left intact!

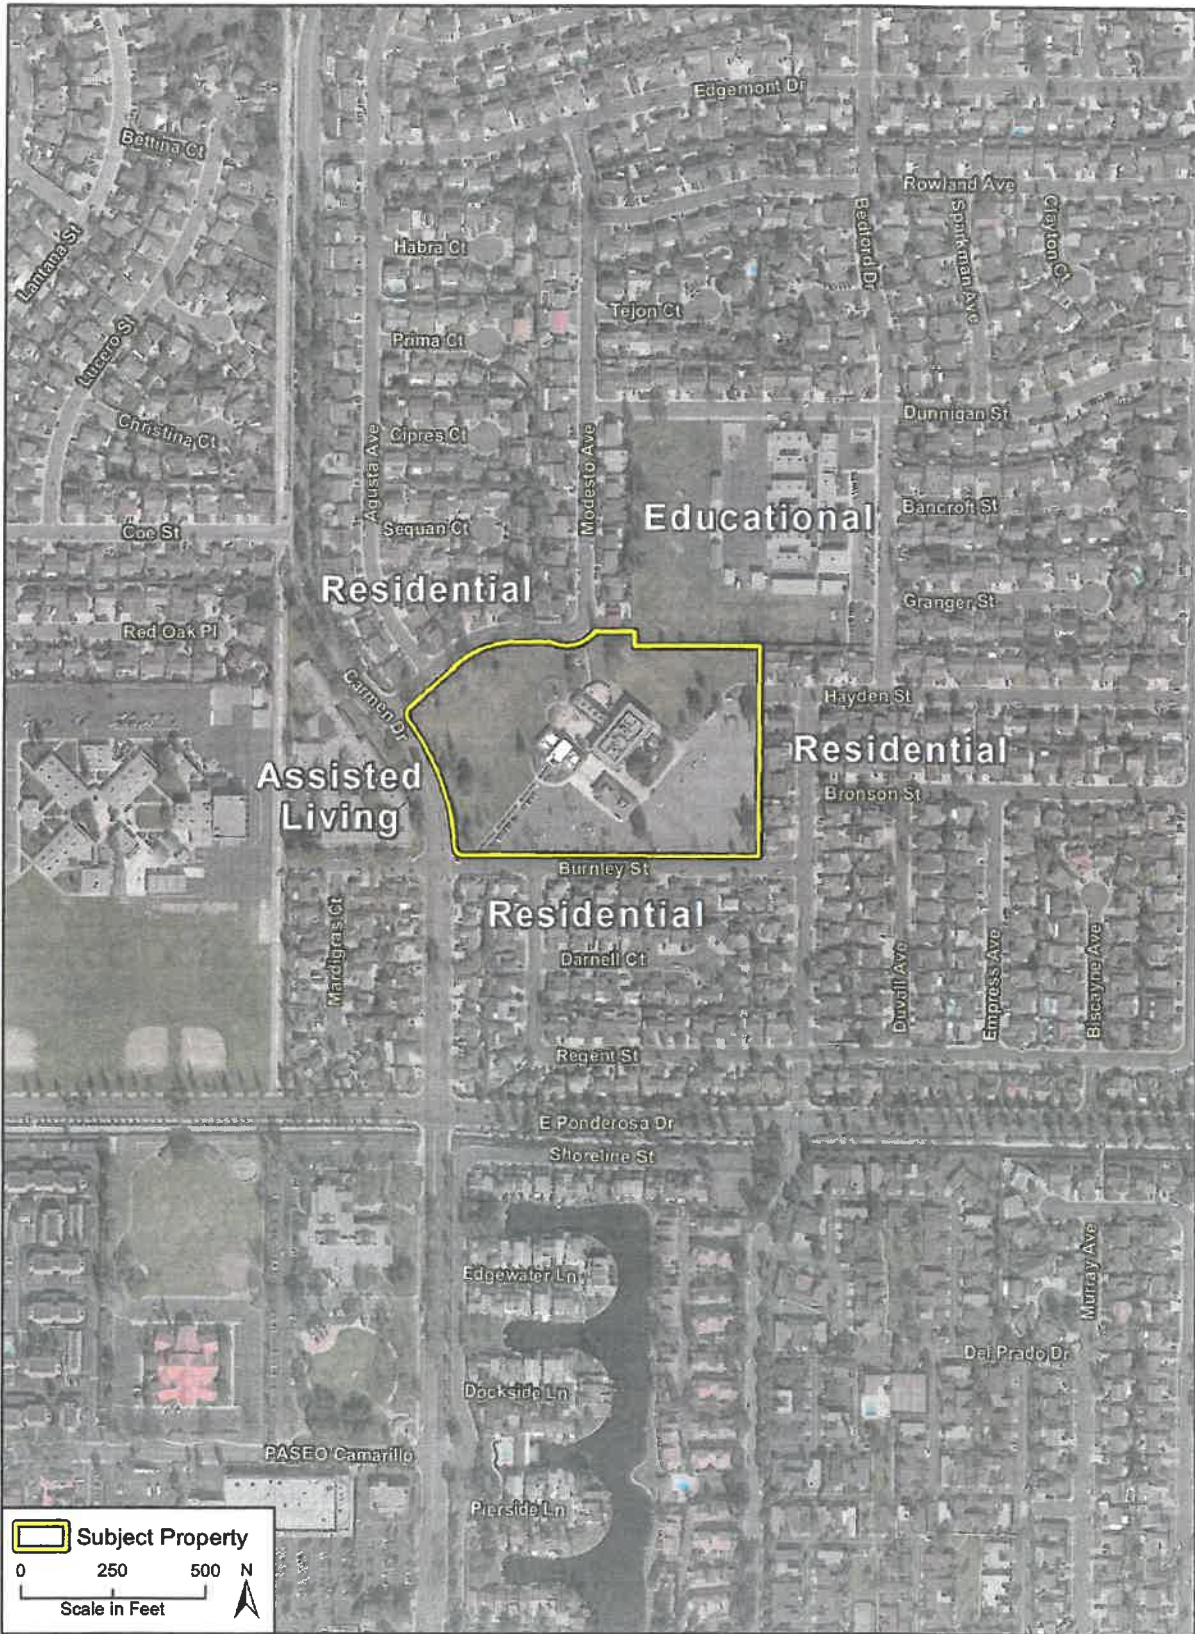
Figure 3

Adjacent Land Use Map

The subject property is located in an area that is primarily composed of residential and educational land uses. Properties in the vicinity of the subject property include single-family residences, a school and an assisted living facility. The current adjacent land uses are described in Table 1 and depicted on Figure 3, Adjacent Land Use Map.

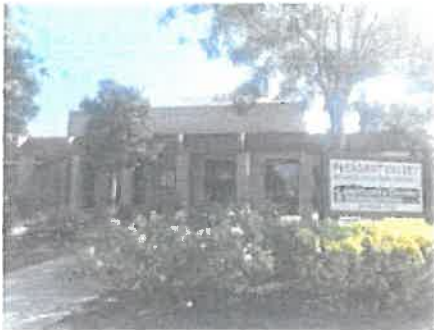
**Photograph 1.** View of the Administration building located on the subject property, facing northwest.

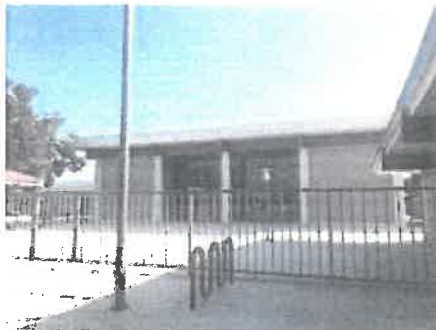
**Photograph 2.** View of the Community Center Building, facing north.

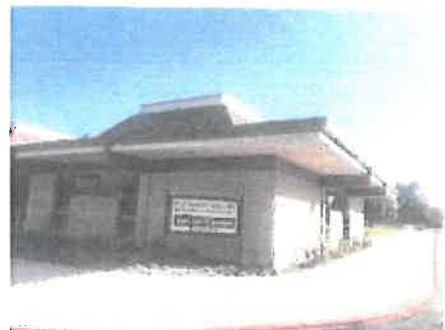
**Photograph 3.** View of the Senior Center Building, facing north.

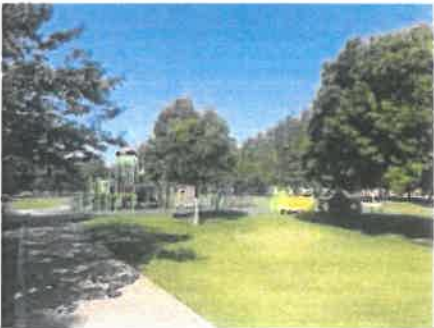
**Photograph 4.** View of the play structure and grass area located on the subject property, facing west.

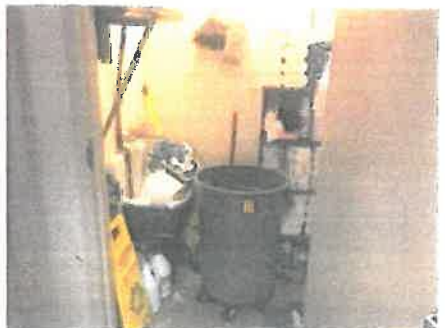
**Photograph 6.** View of a storage room located in the Administration Building.

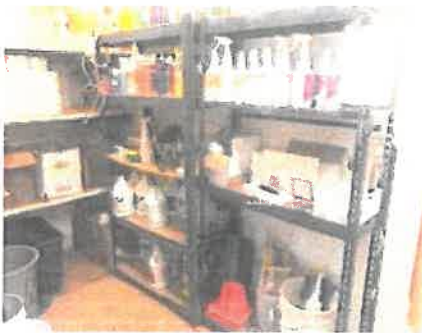
**Photograph 7.** View of a storage room containing cleaning supplies located in the Community Center Building.

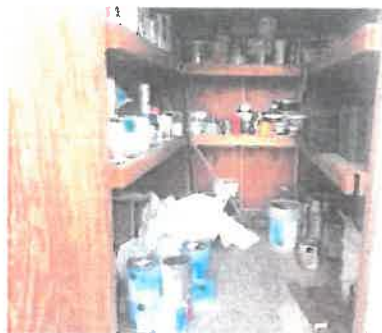
**Photograph 8.** View of an outdoor storage shed containing paint containers.

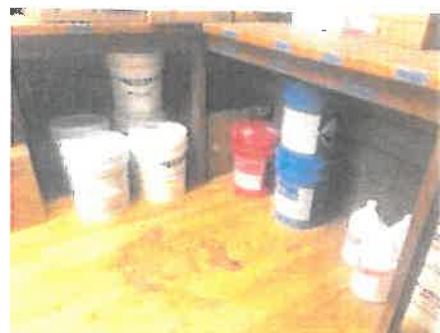
**Photograph 9.** View of a storage room containing floor sealant located in the Community Center Building.

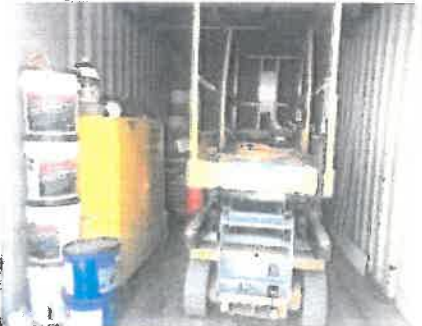
**Photograph 10.** View of an outdoor metal storage container with driveway and roof sealant and a flammable storage cabinet.

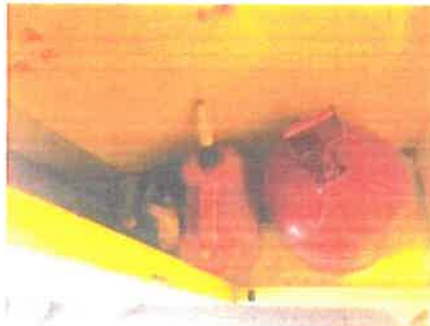
**Photograph 11.** View of the flammable storage cabinet containing small portable fuel containers.

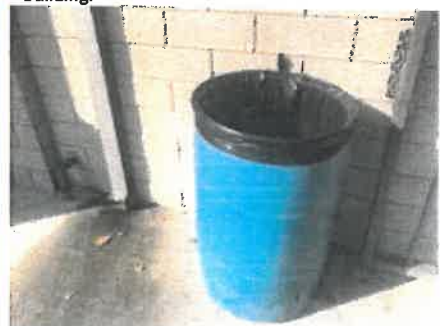
**Photograph 12.** View of a plastic drum in use as a trash can.

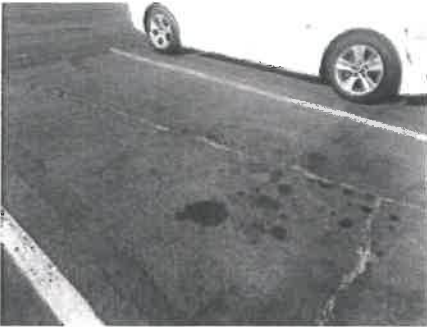
**Photograph 13.** View of surficial staining on asphalt located in the parking lot area on the subject property.
